# Bird mortality due to hazardous powerlines in East Oromia and Afar regions, Ethiopia, 2019

## TECHNICAL REPORT under action A3 of the “Egyptian Vulture New LIFE” project (LIFE16 NAT/BG/000874)

January 2020  
Nairobi

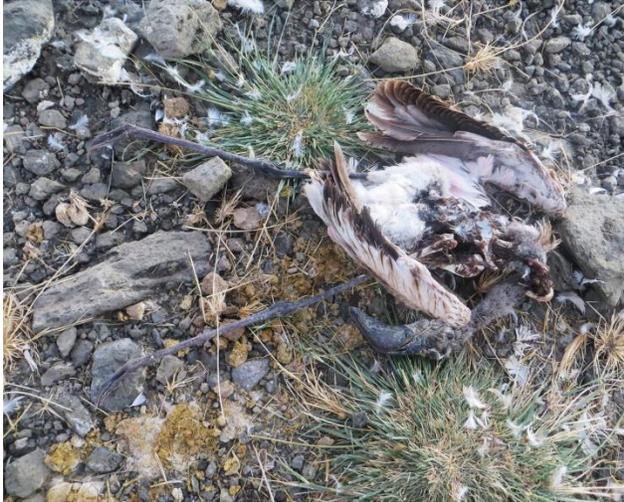
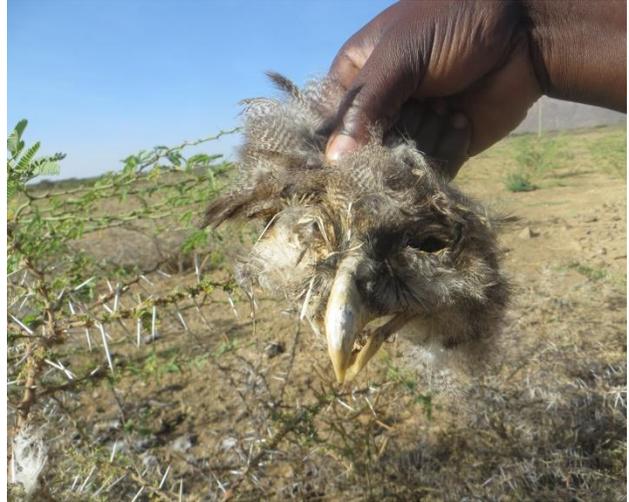
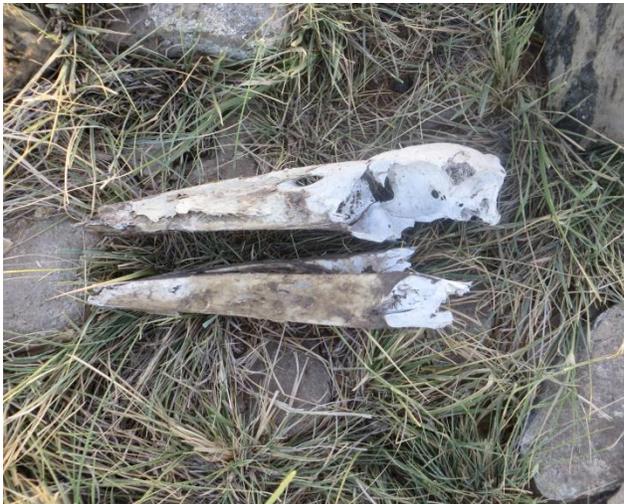
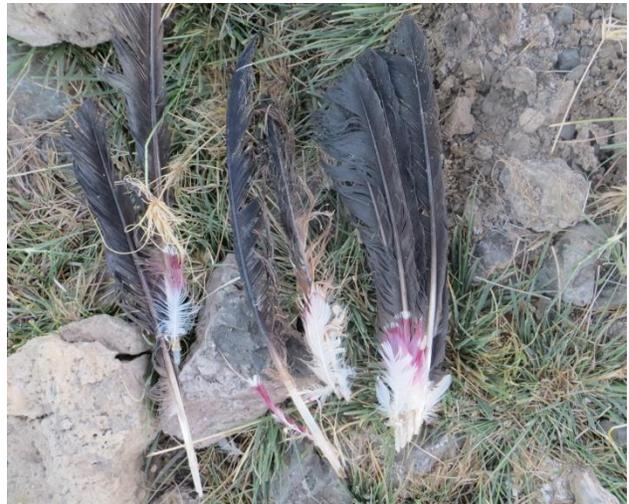
**Fig. 3.** Electrocution or collision victims of other species around Metahara, 2019 (photos: S. Nikolov).

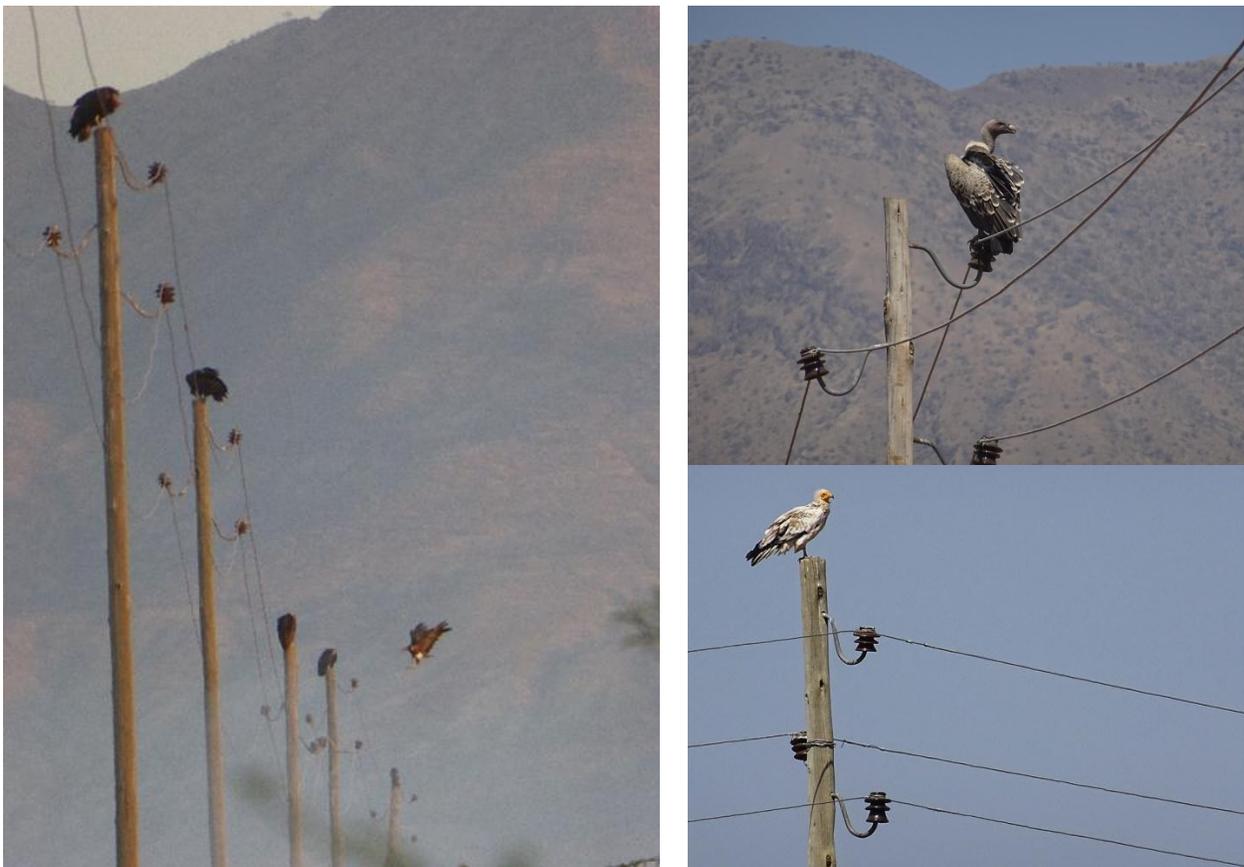
The main reason for the high vulture mortality due to the powerlines near Metahara is the presence of three reliable food sources: the rubbish dump near Lake Basaka (where up to 60 vultures forage every day), and two abattoirs (the local slaughterhouse, and the export abattoir 5 km south of Metahara). In addition, people from the town dump their dead animals in the area near the local slaughterhouse. These abattoirs regularly provide large quantities of food when animals are slaughtered, and vultures and other birds therefore perch on tall structures that allow them to survey for potential food availability and to digest after feeding (Fig. 4). In addition, the two telecommunication antennas in Metahara also serve as nocturnal roost for >100 Hooded Vultures, and the high-voltage power pylons in Awash National Park serve as nocturnal roost for >200 Egyptian Vultures.

**Fig. 4.** Photos showing one of the surveyed low-voltage power lines next to the local and the export abattoirs, with vultures perched on almost every single pylon. Although this pylon type is less dangerous than the metal crossbar type, vultures get electrocuted when they spread their wings during landing and take-off (photos: V. Arkumarev & S. Oppel).

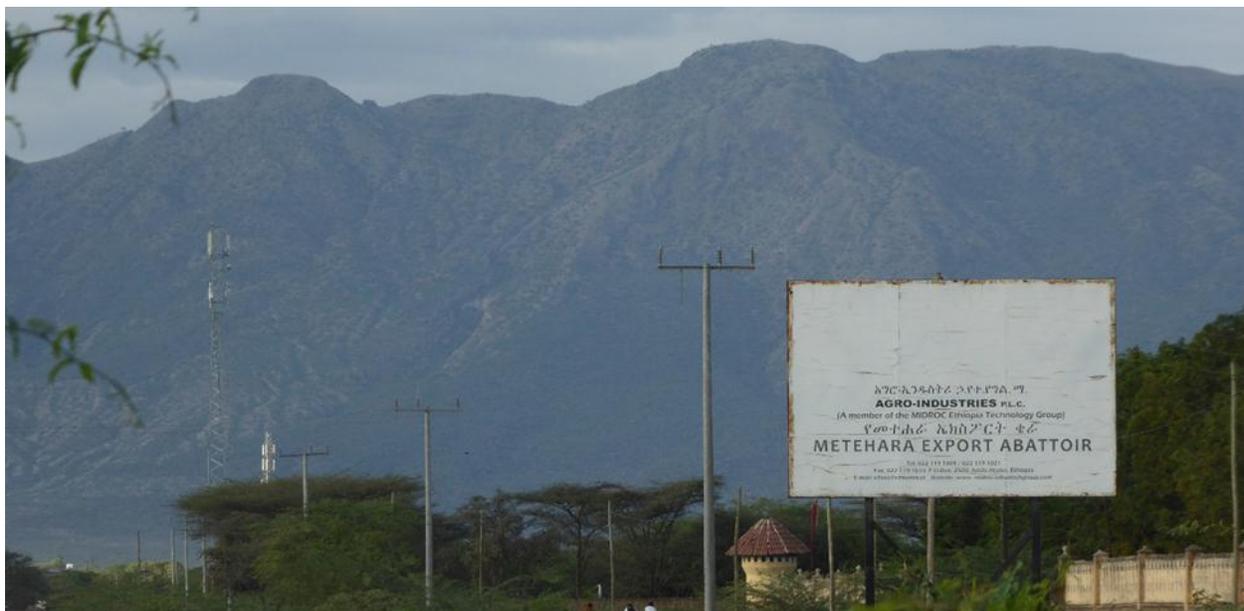
In December 2019 we discovered that a new powerline is being constructed to the Metahara export abattoir – one of the main food sources that attracts a large number of birds. This powerline has the typical metal crossbar design and is therefore even more dangerous than the already existing line with wooden poles (**Fig. 5**). This line will extend 5 km from Metahara to the export abattoir. Based on our current evidence, we project that this line will cause the death of 66 vultures and 8 other birds every year (**Tab. 3**).

**Fig. 5.** New power pylons erected near the Metahara Export Abattoir, a reliable food source for vultures. Note that the design of these pylons, with a metal crossbar and propped up insulators,

will pose an extreme electrocution risk for large birds like vultures and marabous (photo: S. Oppel).

- **In long term**, we recommend that all new electric infrastructures use a design which is safe for birds.

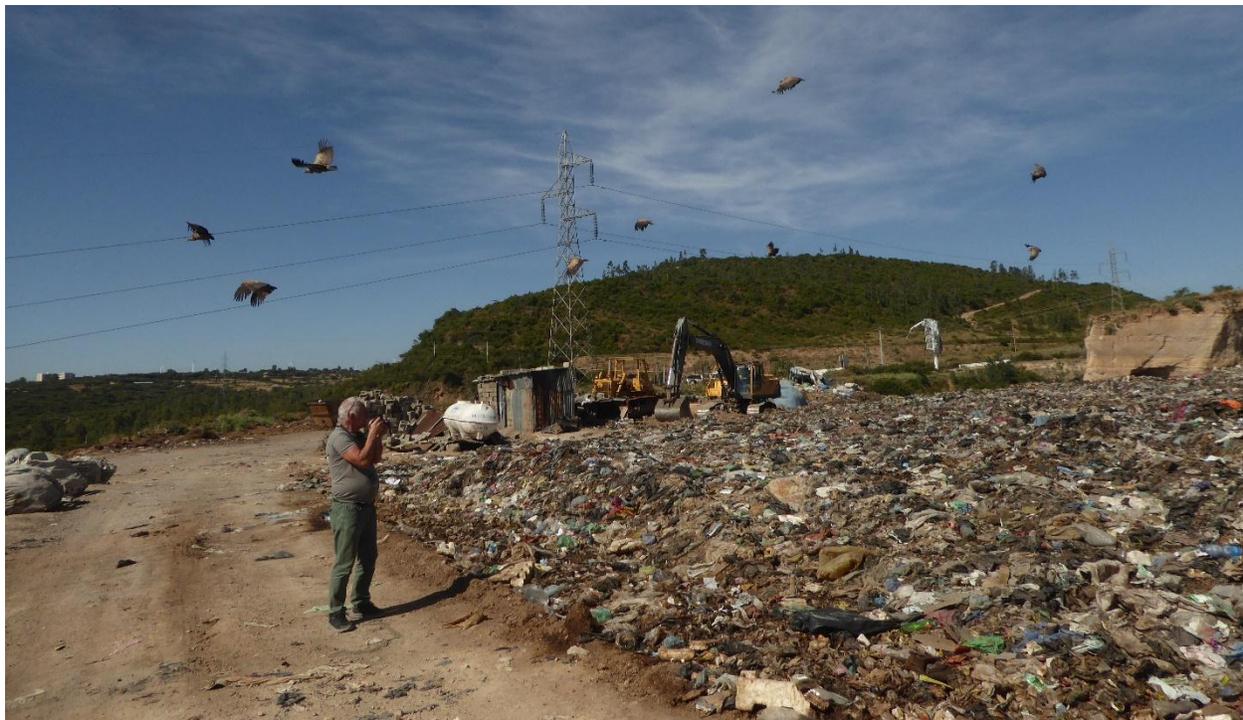
In Adama, we observed a high voltage transmission line next to the rubbish dump west of Adama which poses a very high collision risk (**Fig. 6 & 7**) – in just less than half an hour, we observed tens of vultures miraculously missing the lines and observed one White-backed Vulture flying into lines and falling down the cliff. Hundreds of different species vultures and Marabou Storks feed on the rubbish dump and are routinely exposed to the danger of collision with the transmission line which descends into a valley and is invisible against the valley background, so that birds taking off from the rubbish dump can easily collide with any of the four different cables.

**Fig. 6.** Vultures leaving the Adama rubbish dump are at extremely high risk to collide with the adjacent power transmission line (photo: S. Oppel).

- **In short term**, we strongly recommend: (1) Retrofitting 100 hazardous poles (**Fig. 12**) around Metahara, and 36 hazardous poles (**Fig. 13**) around Logya with insulation caps; (2) Installing diverters/reflectors on 5 km powerlines in Metahara and 2 km powerlines around Logya as per the locations shown on **Fig. 11**, and on 0,8 km multi-tiered high-voltage transmission line around Adama rubbish dump **Fig. 7**.

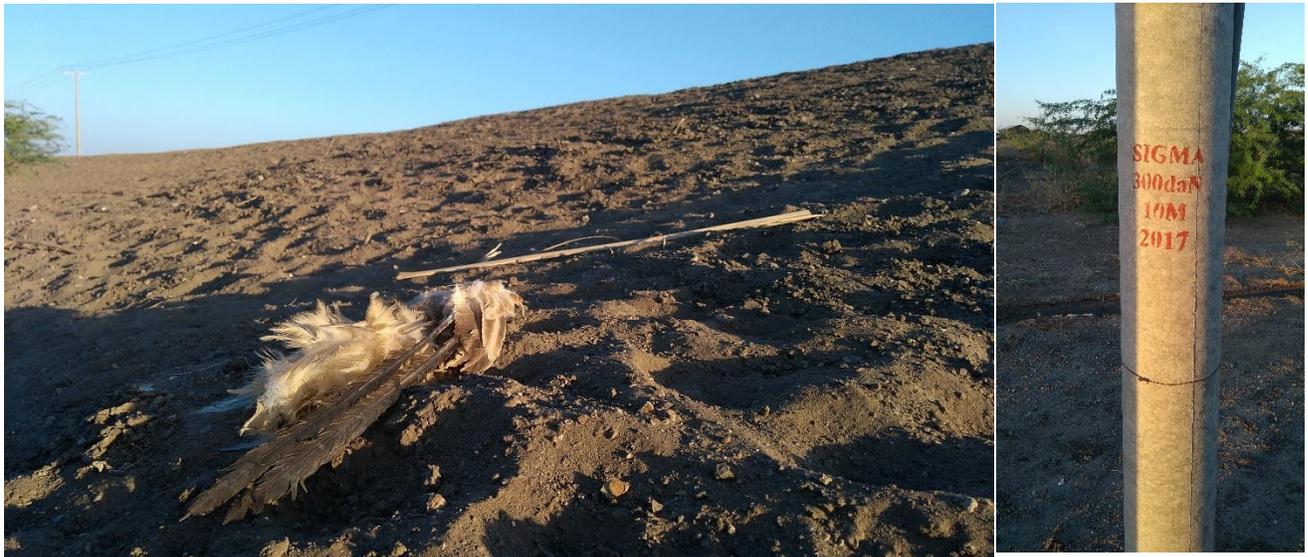
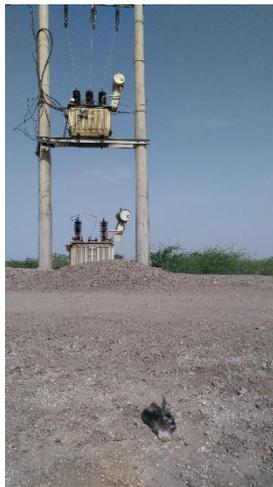
Between January and December 2019, a total of 63.4 km of power lines were surveyed in Logya and 21 bird carcasses (0.33 dead birds per km of powerline) were discovered (Fig. 8 & 9), of which 10 had been electrocuted, 6 had died from collisions, and 5 had died of unknown causes. Among the 21 carcasses, 8 were vultures (5 Egyptian Vultures – all electrocuted, 2 Rüppell’s Vultures, both collided with a line, and 1 Hooded Vulture died of unknown cause). In addition, in January 2019 a live Egyptian Vulture was found in very poor health state and died under veterinary care. The vulture had suffered chronic exposure to lead but the post-mortem revealed injuries that were consistent with the collision with a power line.

Two powerlines were particularly dangerous: One that had been built in 2017 (**Fig. 8**) runs parallel to an irrigation canal just north of the main dump where animal faeces and livestock remains are disposed of. Because this dump is highly attractive to vultures and marabous, the line poses a collision risk when birds approach the dump from the north. The line also provides deceptive roosting opportunities, but due to the dangerous design of the pylons, roosting birds get electrocuted.

**Fig. 8.** Egyptian Vulture and Marabou Stork carcasses at a small distribution line between the cattle market of Logya and the rubbish dump for animal faeces and remains. This line was built in 2017 and runs 1 km along an irrigation channel and poses an extremely high electrocution and collision risk (photo: S. Oppel).

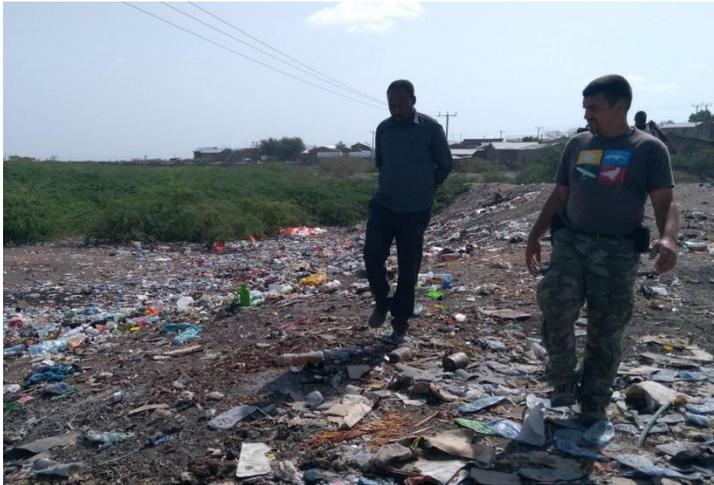
A second very dangerous distribution line along the outskirts of Logya runs along the rubbish dump on the edge of the Awash river bed on the eastern periphery of Logya.

**Fig. 9** Searching for victims in the rubbish under a distribution line on the eastern periphery of Logya (photo: S. Oappel).

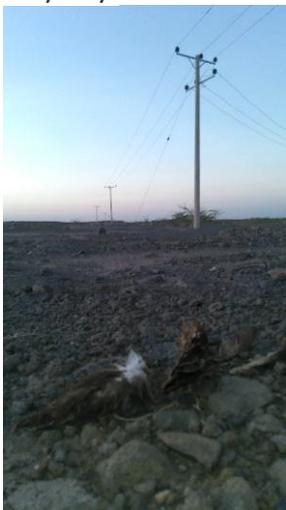
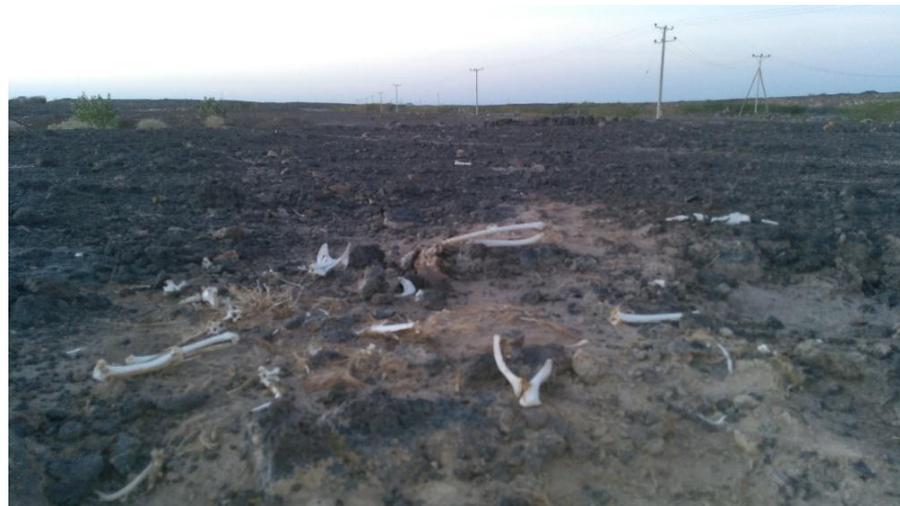
In December a potentially dangerous line was discovered between Semera and Dubti, which has a dangerous design and runs past a permanent water source which is frequently used by vultures for drinking. Although no victims were found next to the water source, two carcasses (1 Marabou Stork, 1 unidentified raptor) were found 3 km south of the water source along the same line, and the line is hazardous for the Egyptian Vultures gathering at this water source every day.

**Fig 10.** Bird carcasses under a small distribution line between Semera and Dubti in December 2019.

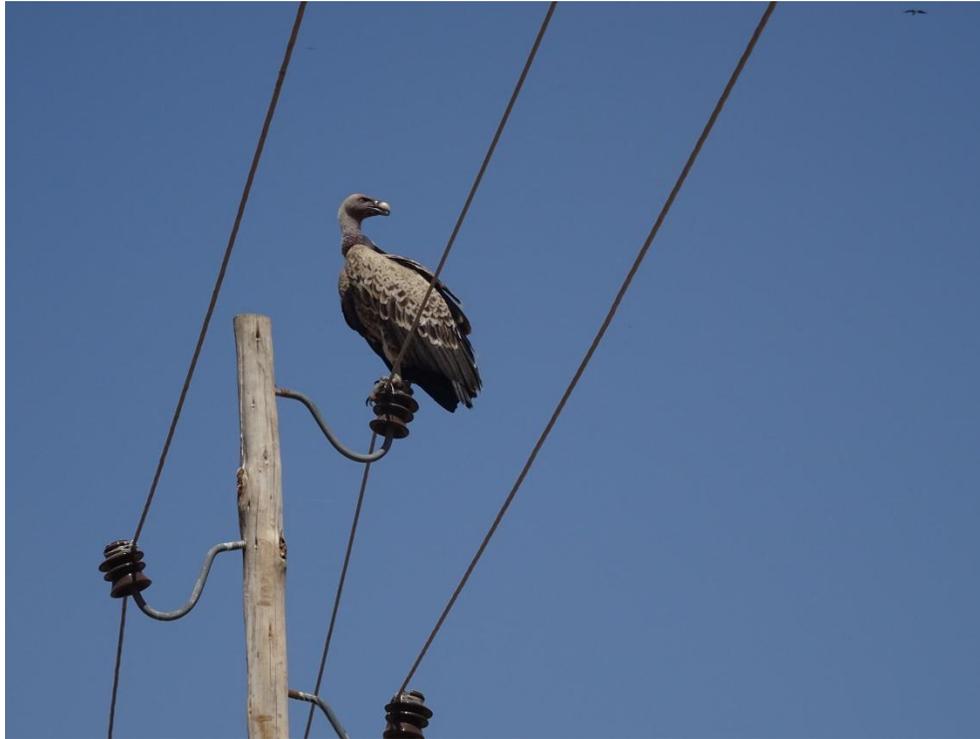
- The presence of reliable food sources, and thus large numbers of Egyptian vultures and other vultures, makes Metahara and Logya important places to ensure that power grid is safe for large birds. However, the current low- and medium-voltage electricity distribution infrastructure is unsafe in terms of both electrocution and collisions. **We identified 5 km of powerlines around Metahara and 2 km around Logya that permanently cause substantial mortality of vultures and other birds (Fig. 12).** Thus, urgent mitigation measures are needed.

**Fig. 12.** Hazardous poles to be insulated around Metahara (N = 100) (Photo: V. Arkumarev).

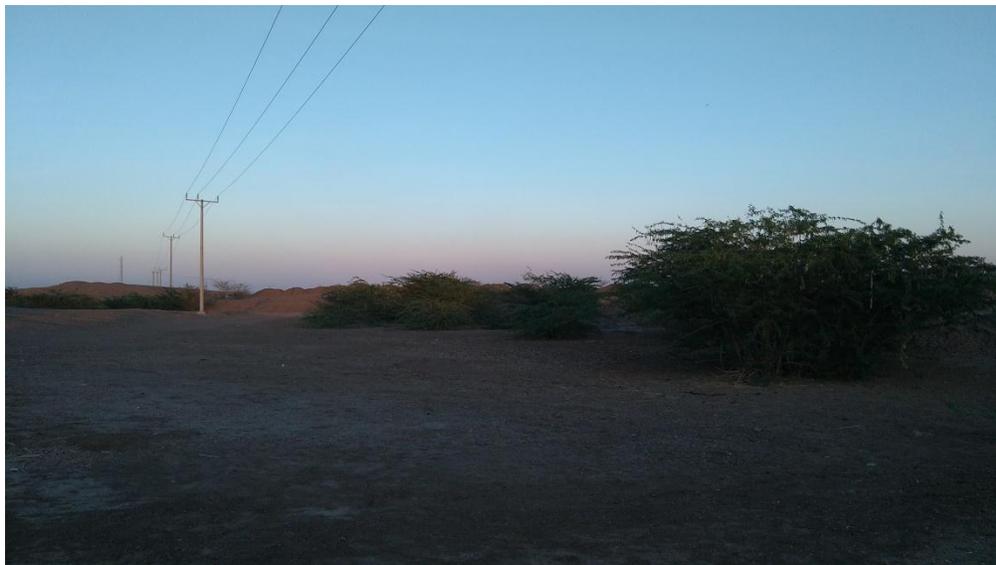
**Fig. 13.** Hazardous poles to be insulated around Logya (N = 36) (Photo: S. Oppel).
