**STUDY ON THE MORTALITY OF BIRDS CAUSED
BY ELECTROCUTION AND COLLISION WITH POWER LINES IN
DRINO VALLEY,
GJIROKASTRA, ALBANIA 2020.**

TECHNICAL REPORT
Under action A3 of the Egyptian Vulture New LIFE project
(LIFE16 NAT/BG/000874)

**AOS - Albanian Ornithological Society
2020**

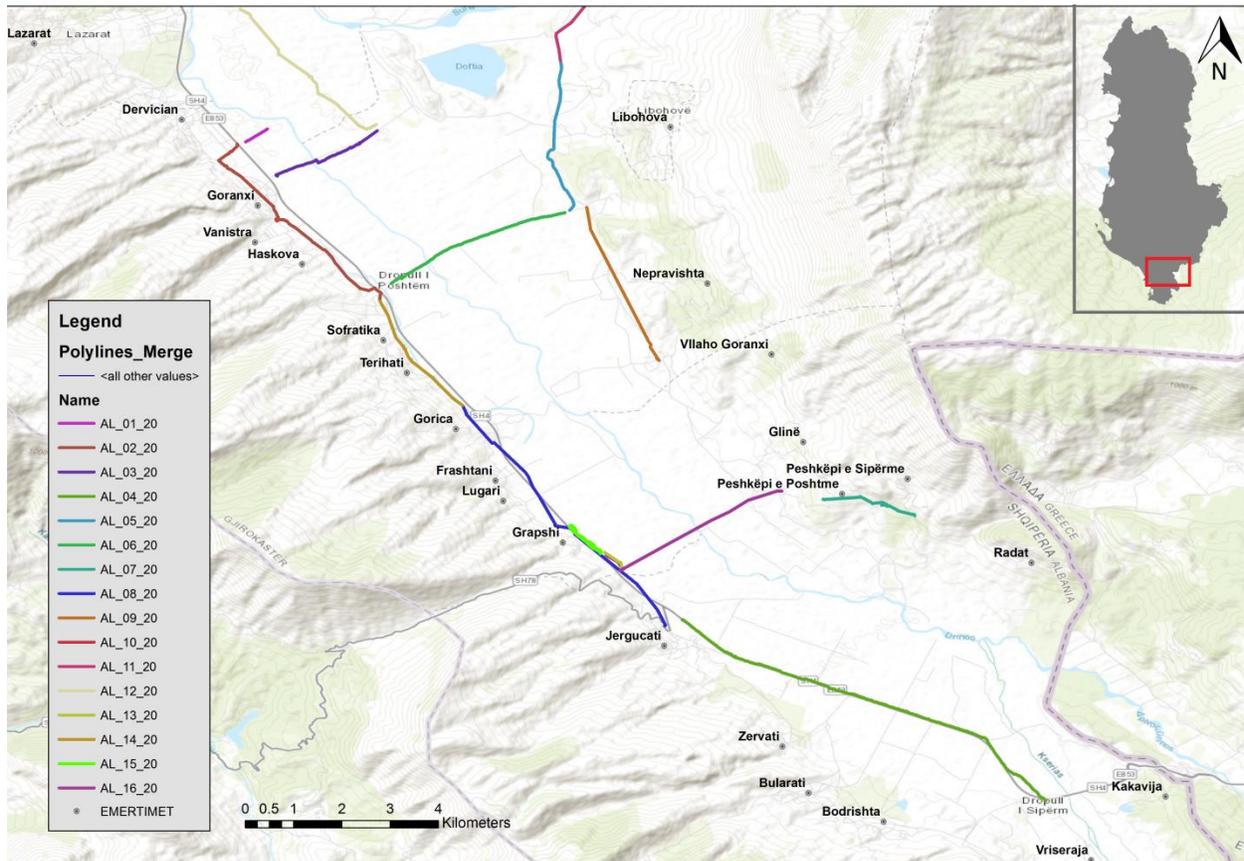
Figure 1. Power lines monitored by AOS in the Drino Valley, 2020.

The monitoring of bird mortality rate caused by electrocution and collision was focused on Drino Valley, near the EV territories, and the largest roosting site in Europe of the Lesser Kestrel. A total of 16 transects were monitored, with a total length of circa 44.2 km, and width of 5-10 m. Low, medium, and high voltage power lines were monitored. In this survey, it was given priority to the transects located in open areas, without tall vegetation, as well as to those transects which are located close to the territories of the Egyptian Vulture and the roosting site of the Lesser Kestrel.

The map below shows all the power lines monitored for 2020 by AOS in Drino Valley, Gjirokastra.

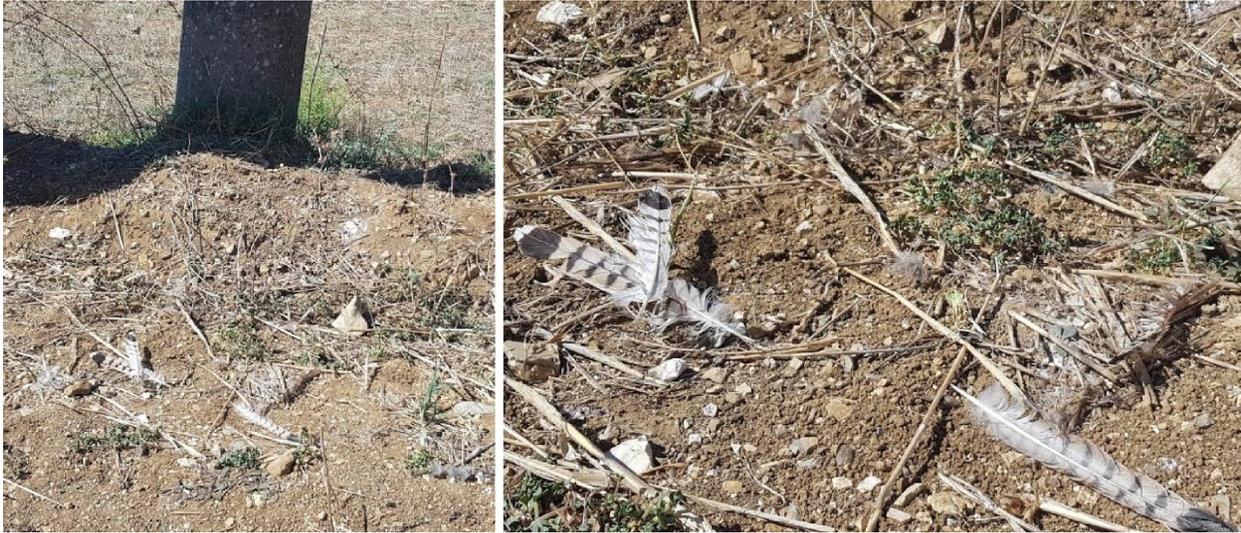
Figure 2. Findings from field monitoring, remains of a Lesser kestrel

The first recorded case by our team were the remains of a Lesser Kestrel (*Falco naumanni*) under the energy pole, which is located near the village of Glina, along the transect with Id: AL_16_20, with point coordinate: Lat: 39 ° 57'48.35 "Lon: 20 ° 17'0.20 ".

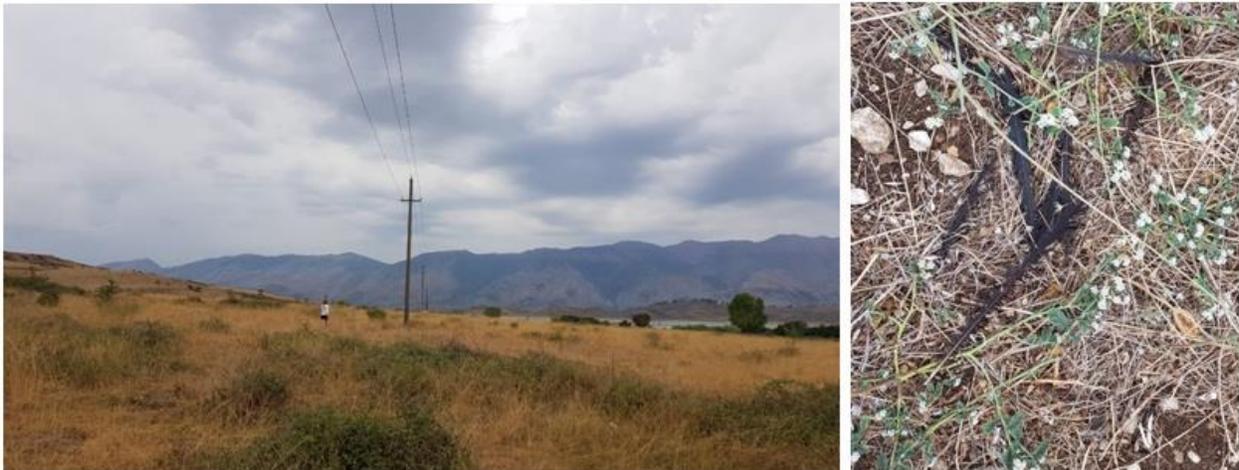
Figure 3. Findings from field monitoring, feathers of a Magpie

While the second recorded case were the feathers of a Magpie (*Pica pica*) found below the power lines, near Bulo, along the transect Id: AL_11_20, with point coordinates: Lat: 40 ° 3'4.03 " - Lon: 20 ° 14'57.83 ".

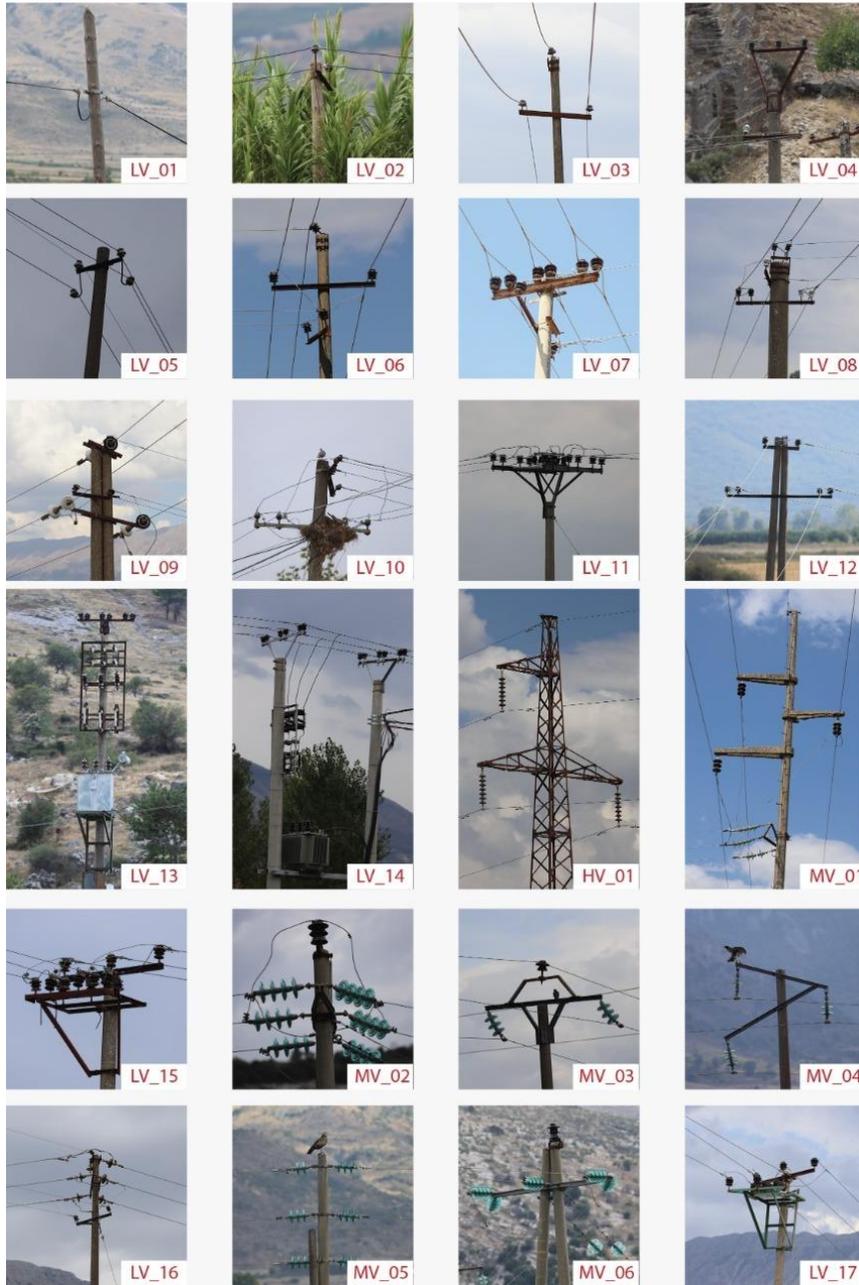
Figure 4. Hazardous power poles identified

In Drino Valley, circa 24 different types of electricity pylons have been identified (figure below). The pylons belong to 3 different categories: the low voltage pylons, the medium voltage pylons, and the high voltage pylons.

The assessment shows that the most problematic pylons in terms of the possibility of electrocution in birds are: LV_04, LV_06, LV_07, LV_08, LV_09, LV_10, LV_11, LV_12, LV_13, LV_14, LV_15, MV_02, MV_05. While medium and high voltage poles appear safer. Specifically, the least hazardous are: HV_01, MV_01, MV_03, MV_04 and MV_06.

1. Retrofitting of electricity poles assessed as dangerous in this study, specifically the pylons in the power lines with ID: AL_16_20 and AL_08_20 (*Figure 5*). These types of poles are shown in *Figure 4* (Pylon type ID: LV_03, LV_04, LV_05 and LV_06).
2. Installation of bird diverters along the power line with ID: AL_04_20 (*Figure 5*).
3. Increase the cooperation with the responsible authorities for the management of the distribution power grid, OSHEE, and OST, in order to conduct the retrofitting of the poles and to take other mitigation measures in the future, constructing and installing bird friendly electric pylons.
4. Continuing the monitoring of the power lines in Drino Valley and expanding the power lines monitoring in other areas where the territories of the Egyptian vulture are located.

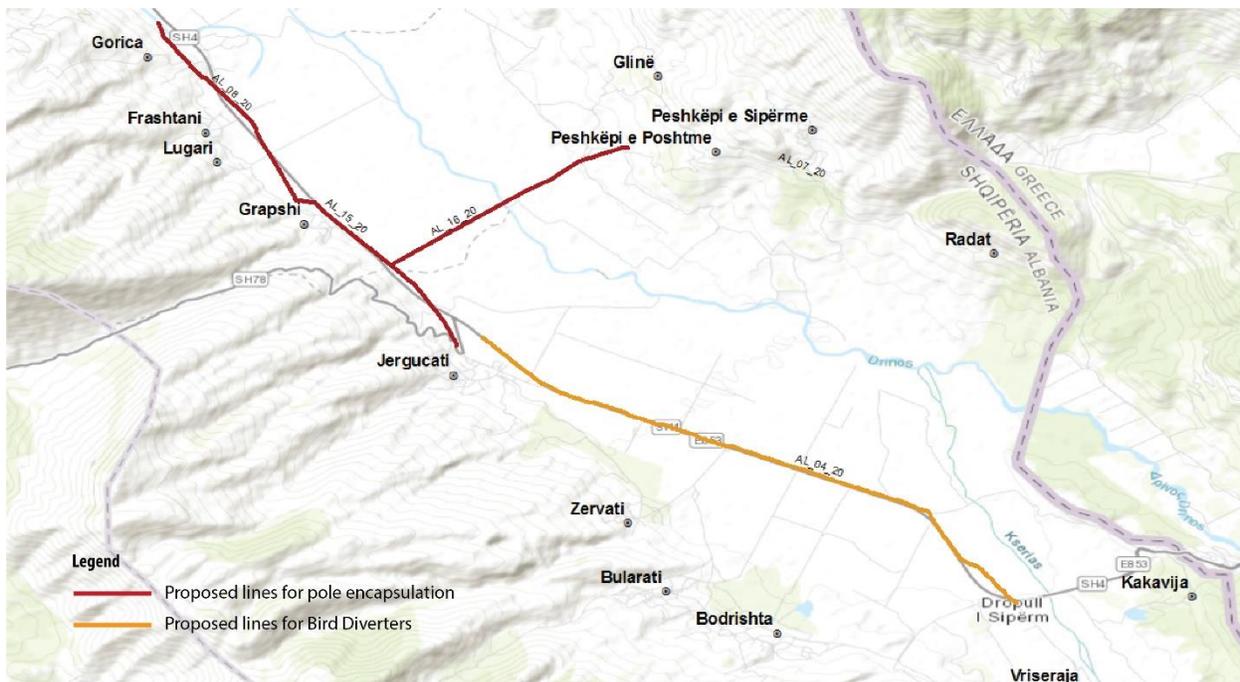
Figure 5. Lines which need to encapsulate the poles.

The most problematic lines are those perpendicular to the Drino valley and the power lines that are close to the Lesser Kestrel roosting site. It is therefore very important to take mitigation measures precisely for these power lines and pylons, consisting mainly in insulation of dangerous pylons in order to prevent electroshock to birds.

The following map (*Figure 5*) shows the assessed dangerous power lines that must be encapsulated in order to prevent electrocution, especially for the Egyptian Vulture, the last breeding vulture in Albania. The most priority transects to intervene with the encapsulation of the pylons and bird diverters are: AL_16_20, AL_08_20 AND AL_15_20.
