STUDY ON THE MORTALITY OF BIRDS CAUSED BY THE POWER GRID IN DRINO VALLEY, ALBANIA, DURING THE AUTUMN MIGRATION 2020

TECHNICAL REPORT

Under action A3 of the Egyptian Vulture New LIFE project (LIFE16 NAT/BG/000874)

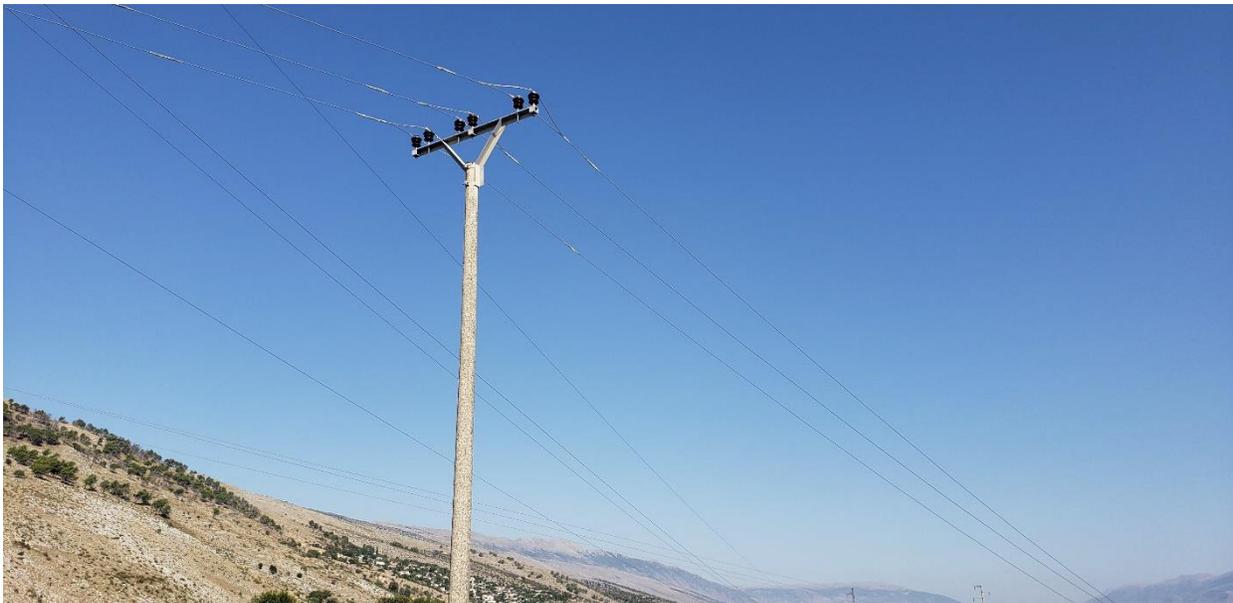
Figure 2. 10 kV power pylon along the transect

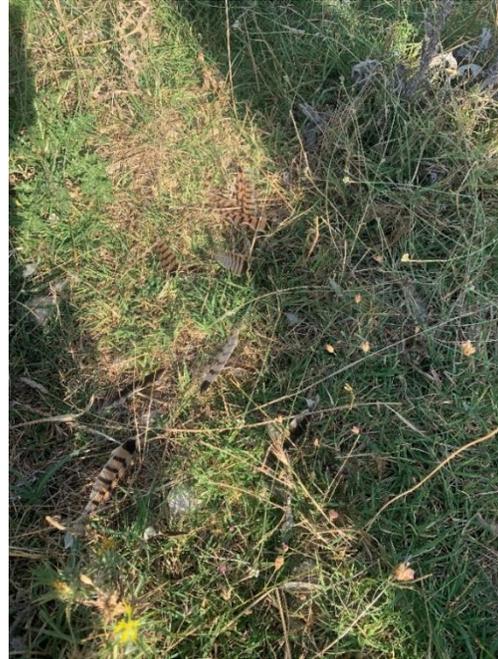
In this transect monitoring we found evidences such as feathers of 2 individuals of common kestrel which were most probably electrocuted (see fig 4 and 6). These evidences were under the same power pylon, maximum 1 m distance from the pylon (fig 4) in entrance of road that connects Drino valley with Glina and Peshkpi (39.944 N; 20.264 E)

Figure 6. Feathers of the two individuals of the common *kestrel* (*Falco tinnunculus*) under the 10 kV power pylon

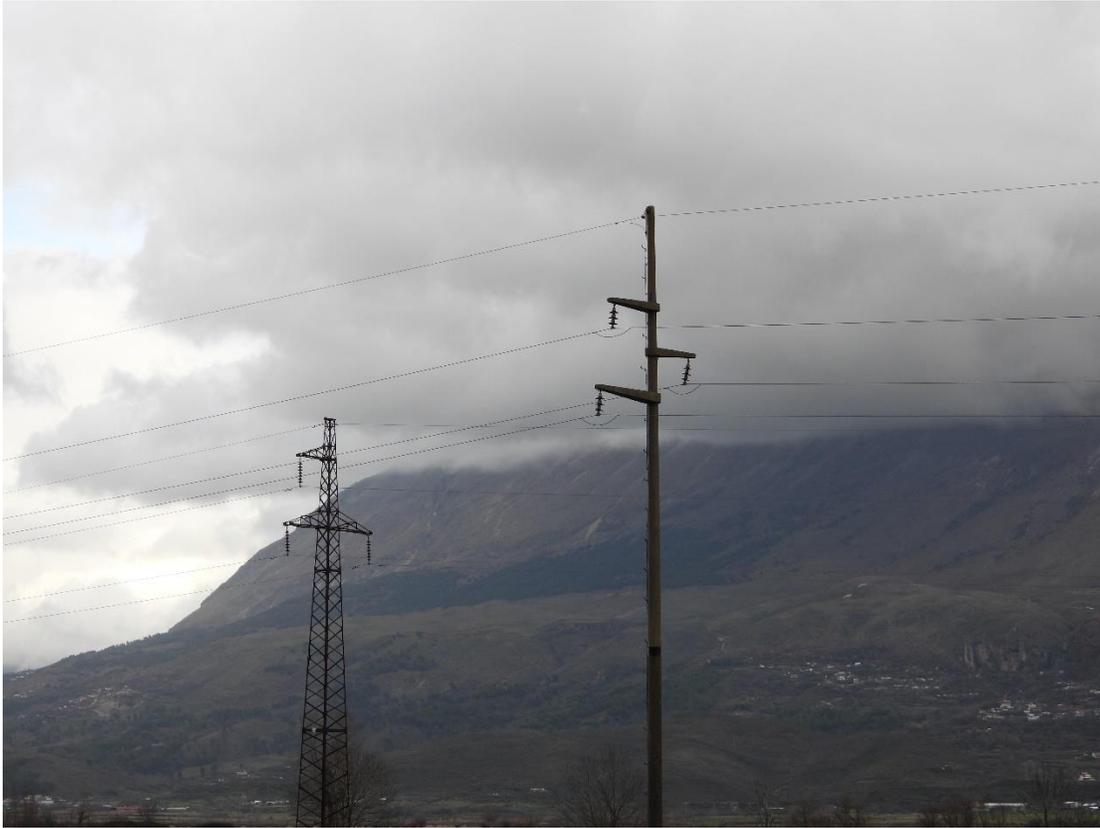
This transect has a total length of 3.7 km and consists of 16 power pylons. The power lines are located in a plain relief and the transect is easy to monitor. Along this transect there are 10 kV and 35 kV power lines in short distance from each other. There were no evidences of bird mortality found during this monitoring.

Figure 10. *110 kV and 35 kV power lines in vicinity of each other in Terihat- Frashtan*

A short segment from Grapsh to Frashtan is used by birds of prey as a feeding ground and the power lines seem to be more dangerous than other parts of the transect. In addition, the powerlines of the transect from Terihat to Frashtan seem to be problematic due to the density of the power grid, with mixed power lines in vicinity with one another (10 kV, 35 kV and 110 kV) increasing the risk of collision. We recommend to install bird diverters/ reflectors on the dangerous powerlines to prevent this phenomenon.

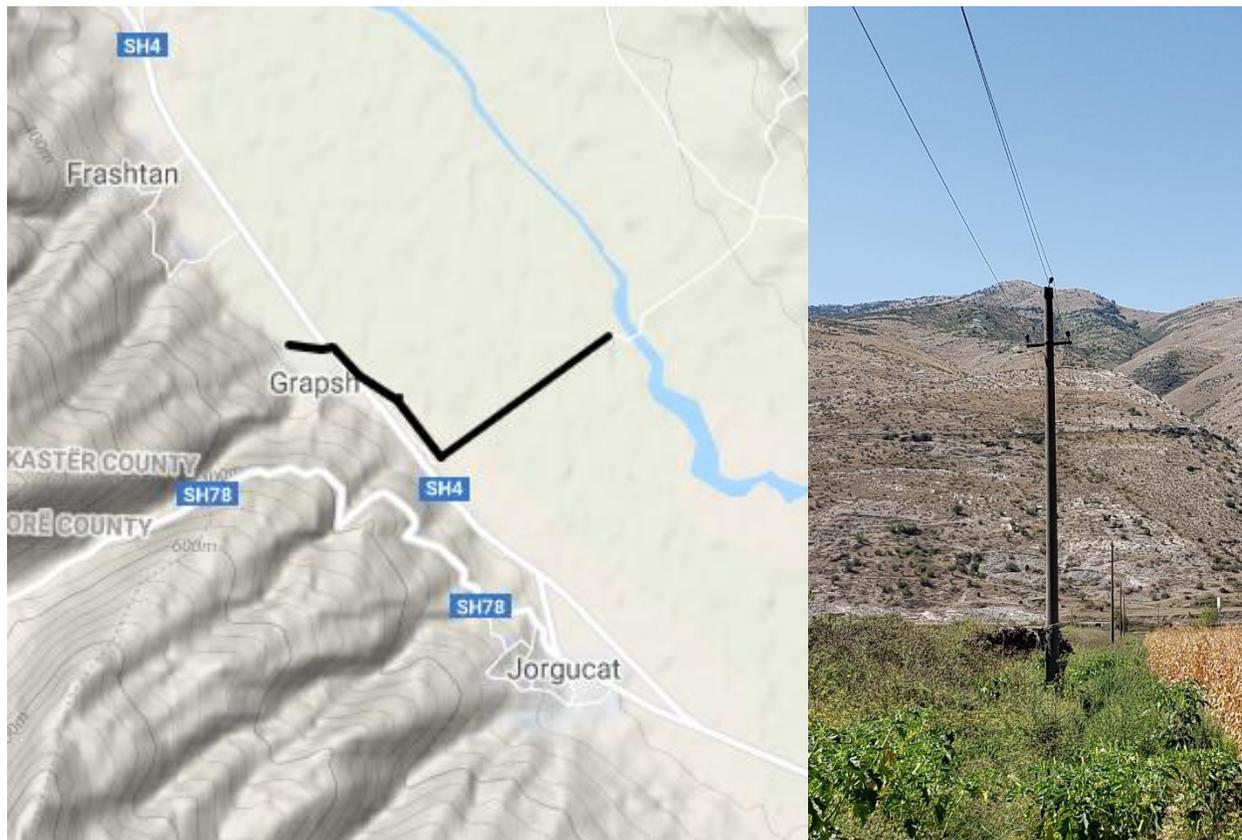
The only evidences for bird mortality that we found were a full carcass of common buzzard (*Buteo buteo*) directly under the power pylon (39.9519074 N; 20.2637416 E), possibly electrocuted (Fig.12 & 14) , and feathers of an individual of lesser kestrel (*Falco naumanni*). (39.9515952 N; 20.2566052 E). (Fig.12). The body was checked but there was not any visible sign to indicate the cause of death.

Figure 11 & 12. Power line in Grapsh-Gline transect; 10 kV power pylon where the dead individual of Common buzzard has been found

Meanwhile, specific power pylons are problematic due to risk of electrocution and need interventions, such as the one in entrance of Glina, the 10 kV power pylon, where two victims (*Buteo buteo*; *Falco naumanni*) were found. (Fig. 12&14). We highly recommend the insulation or retrofitting of the hazardous poles with bird protection covers.

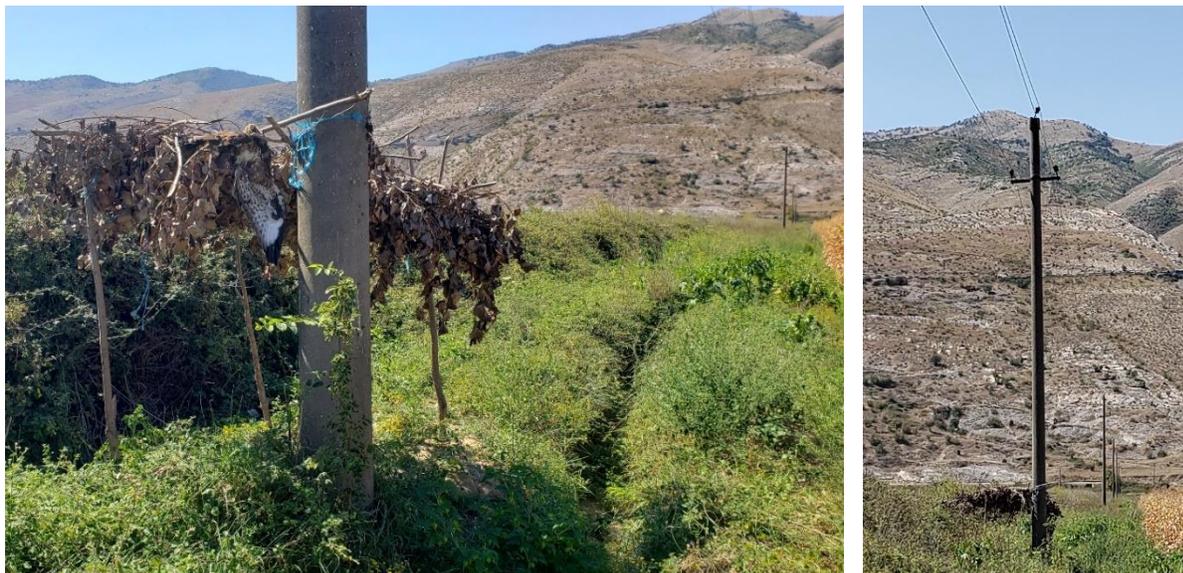
Figure 14: Dead common buzzard (*Buteo Buteo*) under the hazardous power pylon (10 kV)
